Contract #: 04-0120F4Cty: SF/ALA Rte: 80 PM: 13.2/13.9File #: 1.28**WELDING INSPECTION REPORT****Resident Engineer:** Casey, William**Address:** 333 Burma Road**City:** Oakland, CA 94607**Report No:** WIR-027717**Date Inspected:** 05-Jun-2012**Project Name:** SAS Superstructure**OSM Arrival Time:** 700**Prime Contractor:** American Bridge/Fluor Enterprises, a JV**OSM Departure Time:** 1930**Contractor:** American Bridge/Fluor Enterprises, a JV**Location:** jobsite**CWI Name:** William Sherwood**CWI Present:** Yes No**Inspected CWI report:** Yes No N/A**Rod Oven in Use:** Yes No N/A**Electrode to specification:** Yes No N/A**Weld Procedures Followed:** Yes No N/A**Qualified Welders:** Yes No N/A**Verified Joint Fit-up:** Yes No N/A**Approved Drawings:** Yes No N/A**Approved WPS:** Yes No N/A**Delayed / Cancelled:** Yes No N/A**Bridge No:** 34-0006**Component:** OBG**Summary of Items Observed:**

**OBG West Drop-in Splice 13W/14W**

### OBG Suspender Brackets West

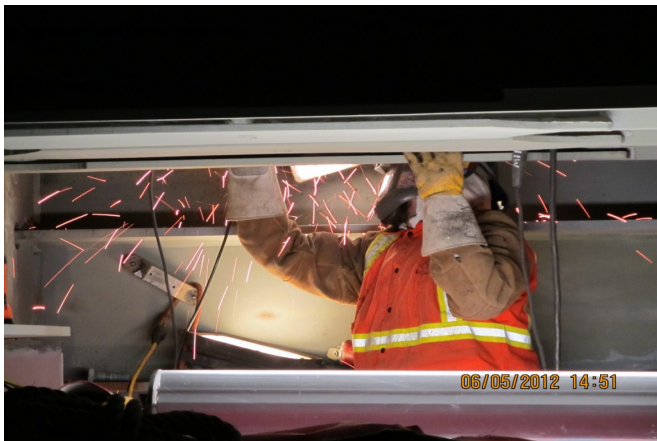
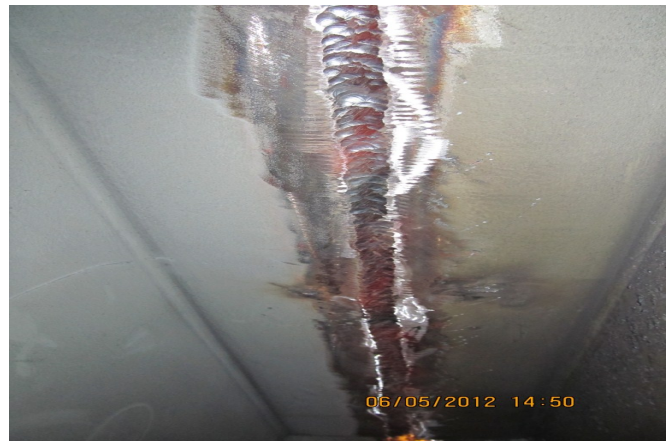
This QAI observed the completion of welding on stiffeners x464-12A of the west side of Suspender Bracket PPE-104W. The welding was being performed by Eric Sparks in the 3G and 4G position using the Shield Metal Arc Welding (SMAW) Process at 126 amps using an E7018H4R consumable electrode.
